SECTION II
INVENTORY AND ANALYSIS

OVERVIEW

The Village of Croton-on-Hudson is located on the eastern side of the Hudson River approximately 40 miles to the north of Manhattan. The Village, covering 4.5 square miles, is in the Town of Cortlandt in the northwestern portion of the County of Westchester.

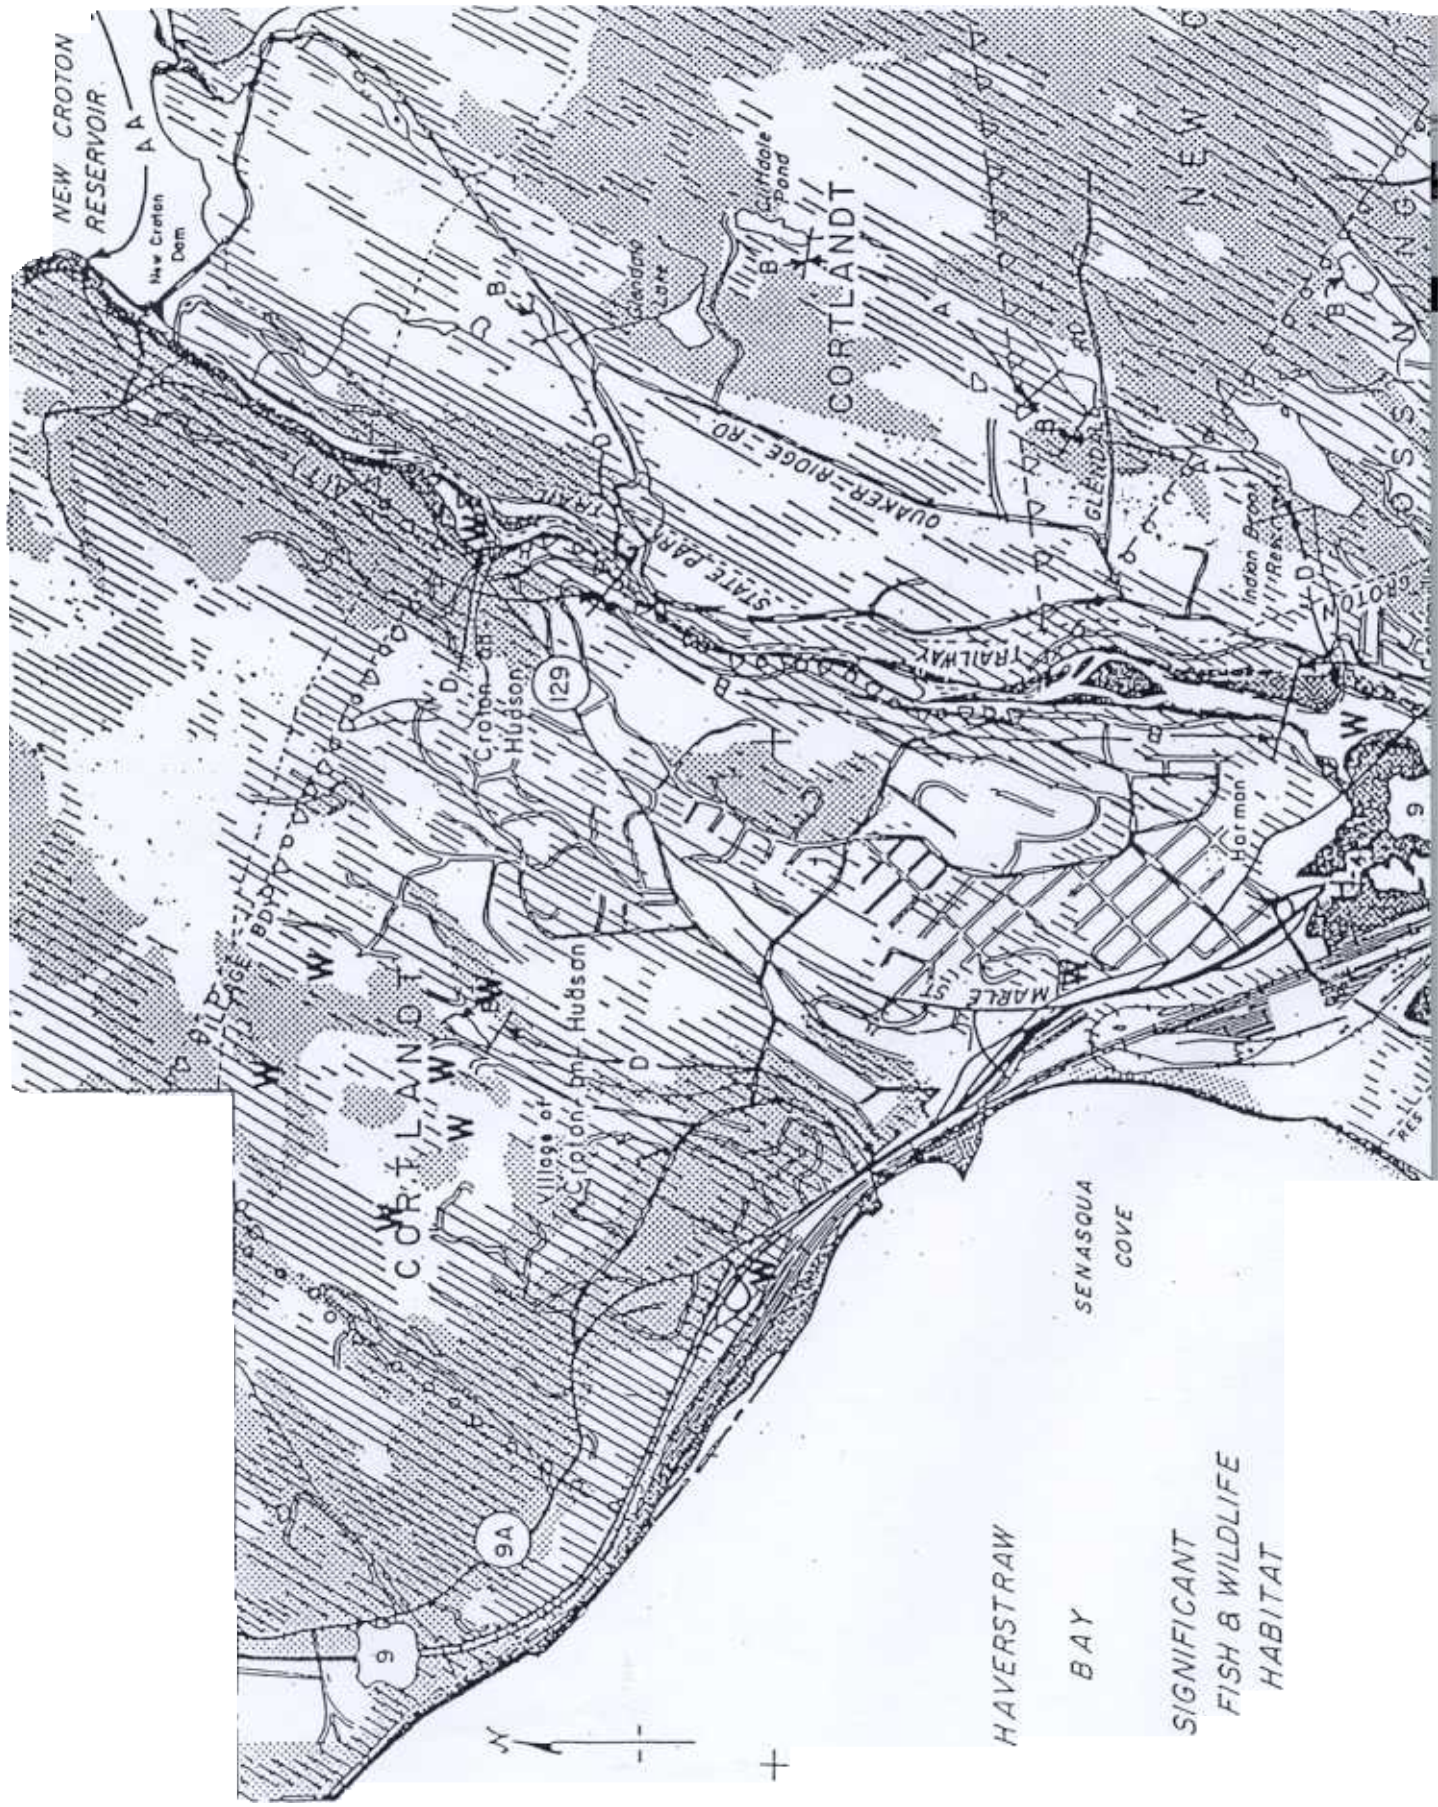
For purposes of best describing the results of the inventory of current land and water uses, the Croton-on-Hudson coastal zone area has been divided into three sections (see Figure 3). Each section has one or more particular characteristics which give it a special identity and to a large extent defines its current land and water use. Of course, as with all arbitrary distinctions, there is some overlap of these special characteristics between the three sections. Figure 3 also includes some land use details referred to in the text.

This section of the Village is bounded on the west by the Hudson River, on the east by Route 9, on the south by the Croton River at the Village's southern boundary, and at the north by the Village's northern boundary along Furnace Dock Road (see Figure 3). It stretches in a north-south direction along the water's edge to the tip of Croton Point Park, around the edge of Croton Bay and back to Route 9. A very small peninsula of land, extending north from Ossining and consisting mainly of railroad beds, is also included in this section. The overwhelming characteristic of this section is its direct frontage on the Hudson River. This advantageous position has made it highly susceptible to development pressures.

The Center Village section is bounded by Route 9 to the west (see Figure 3). The intersection of Route 9 with the Croton River is the southernmost point of this section. The line extends along the Croton River in a northeasterly direction to the Village boundary line. From this point, the Center Village section extends northwest along the boundary line to Mt. Airy Road, along Mt. Airy in a southwest direction to Grand Street, along Old Post Road North to its intersection with Route 9A (N. Riverside Avenue), south on Route 9A to Wolf Road and then along an arbitrary line to Route 9.

There are a number of recreational areas within the Village (See Figure 3), the largest and most notable is Croton Point Park.

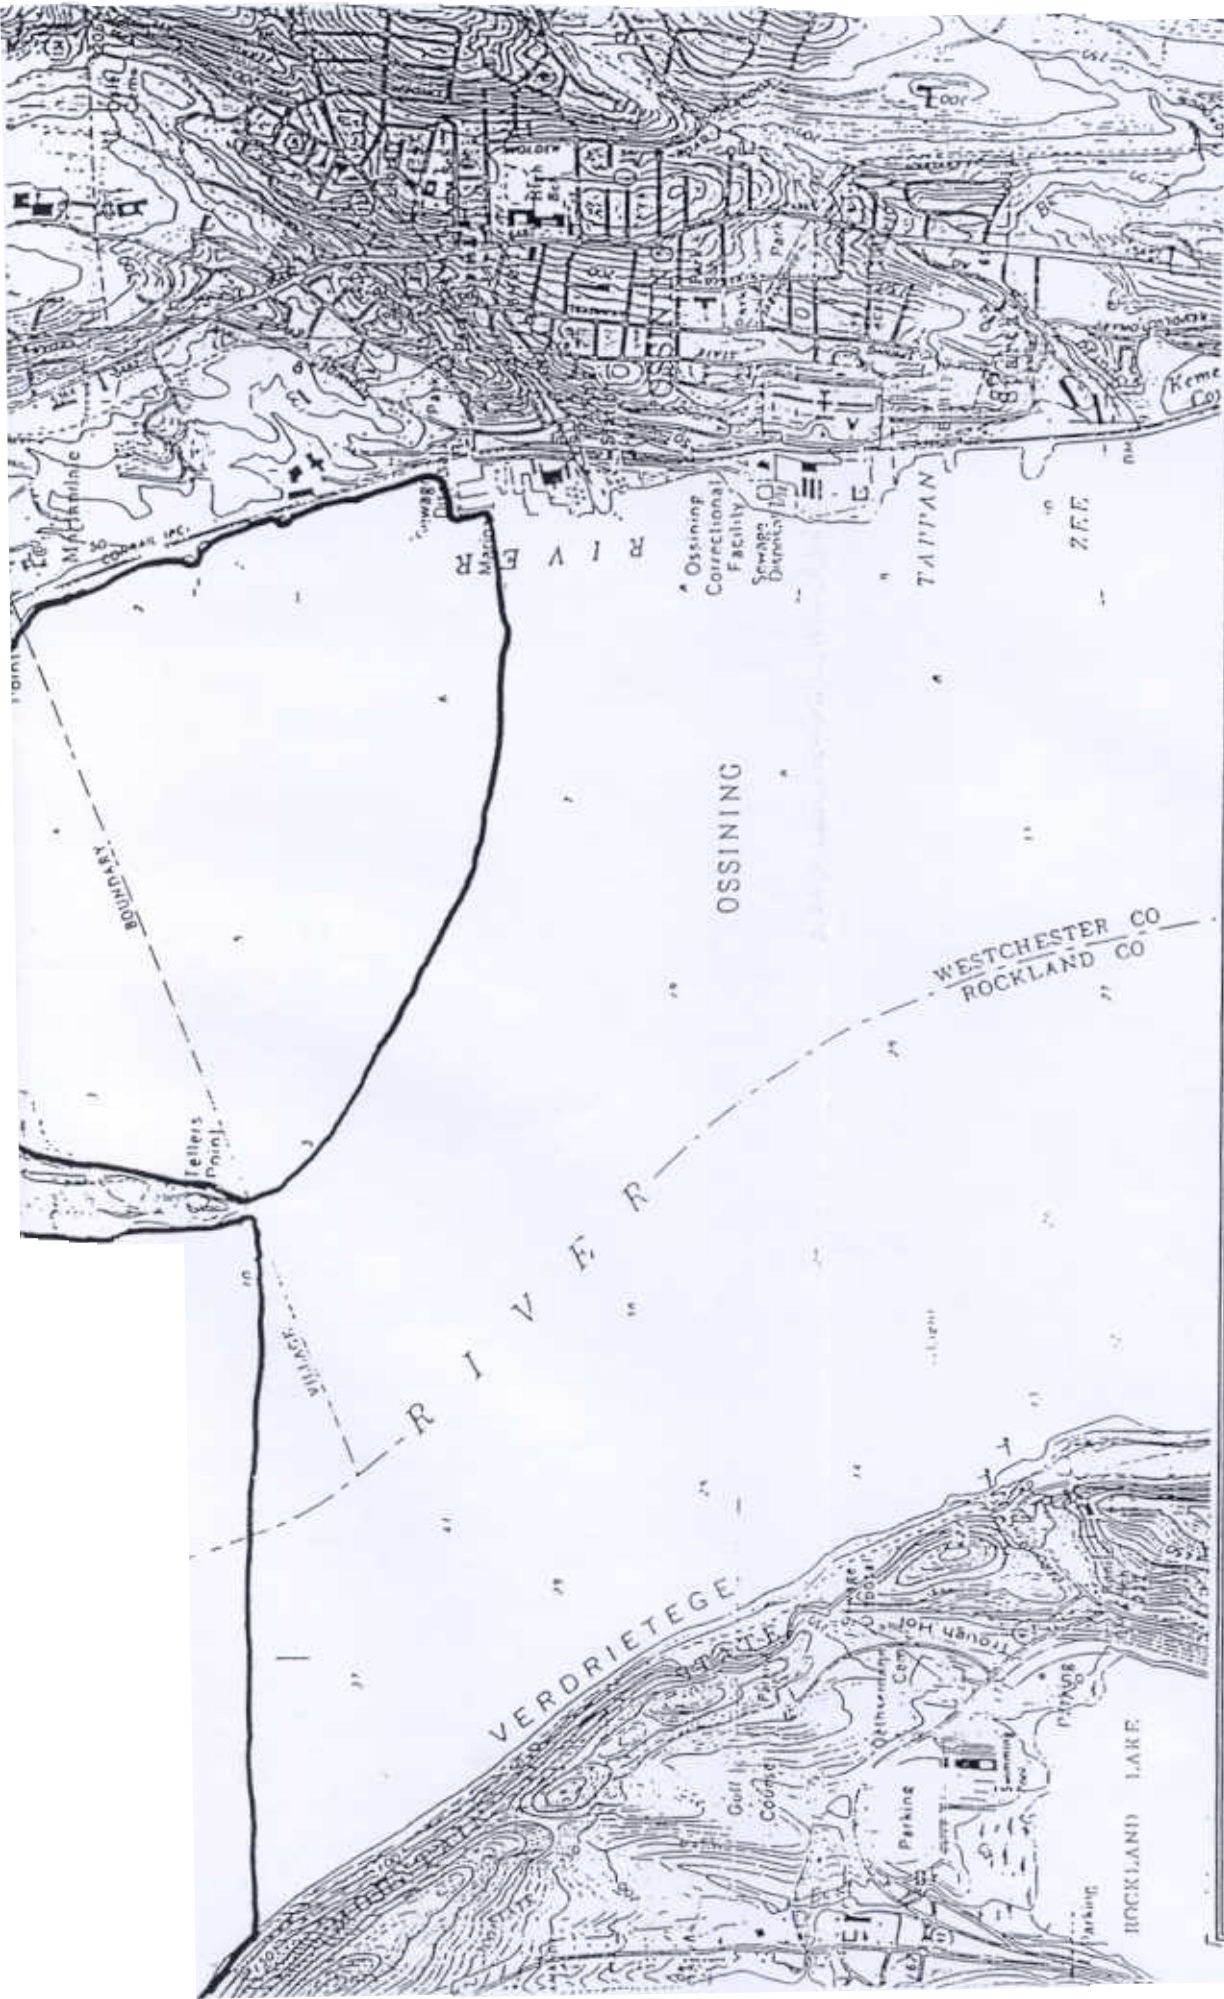
SIGNIFICANT COASTAL FISH AND WILDLIFE HABITATS

Croton River and Bay / Haverstraw Bay (in part)

This narrative, along with its accompanying map, constitutes a record of the basis for this significant coastal fish and wildlife habitat's designation and provides specific information regarding the fish and wildlife resources that depend on this area. General information is also provided to assist in evaluating impacts of proposed activities on parameters which are essential to the habitat's values. This information is to be used in conjunction with the habitat impairment test found in the impact assessment section to determine whether the proposed activities are consistent with the significant coastal habitats policy.

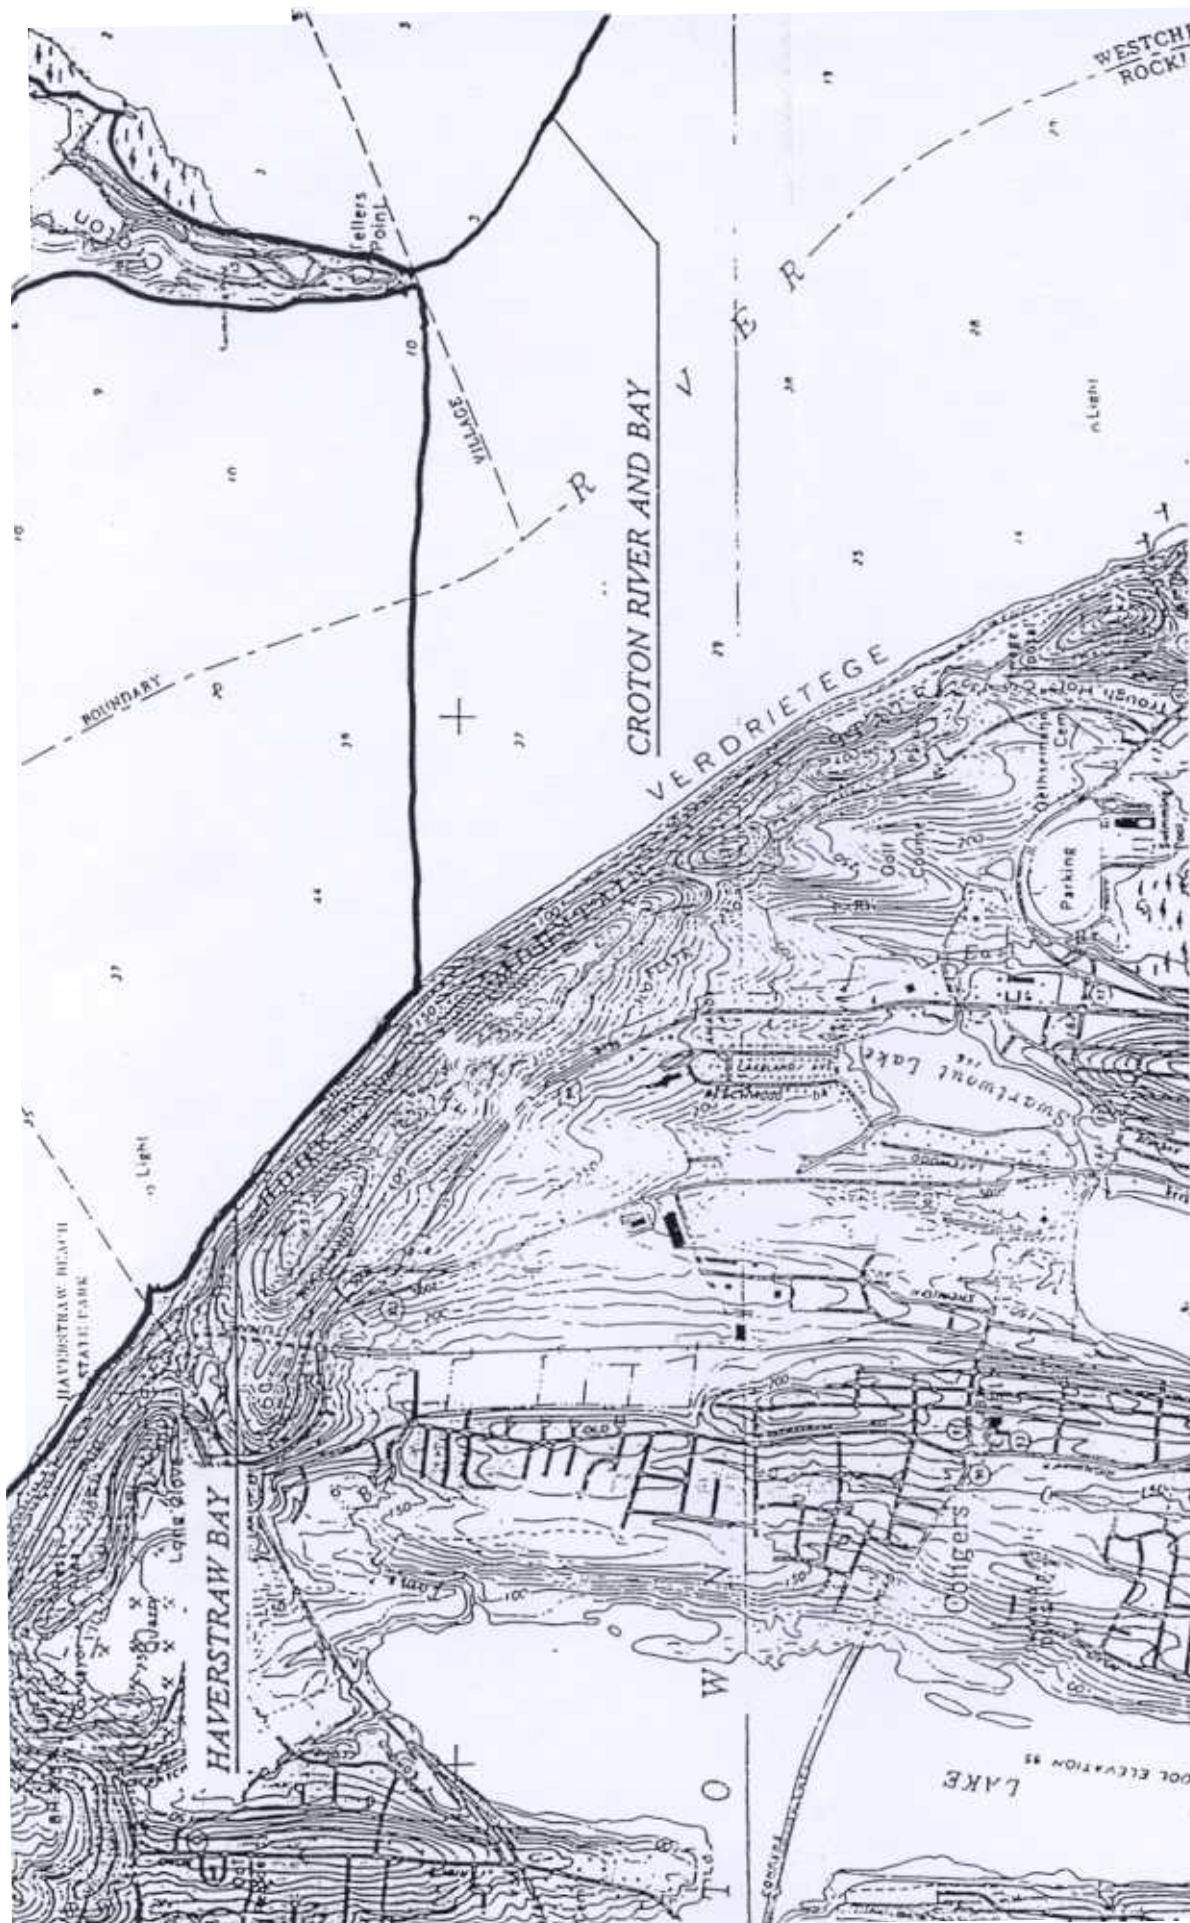
SIGNIFICANT COASTAL FISH AND WILDLIFE HABITATS

Haverstraw Bay (In part) / Croton River and Bay (In part)

This narrative, along with its accompanying map, constitutes a record of the basis for this significant coastal fish and wildlife habitat's designation and provides specific information regarding the fish and wildlife resources that depend on this area. General information is also provided to assist in evaluating impacts of proposed activities on parameters which are essential to the habitat's values. This information is to be used in conjunction with the habitat impairment test found in the impact assessment section to determine whether the proposed activities are consistent with the significant coastal habitats policy.
